Errata

AM62Ax Sitara™ Processors Silicon Errata, Silicon Revision 1.0

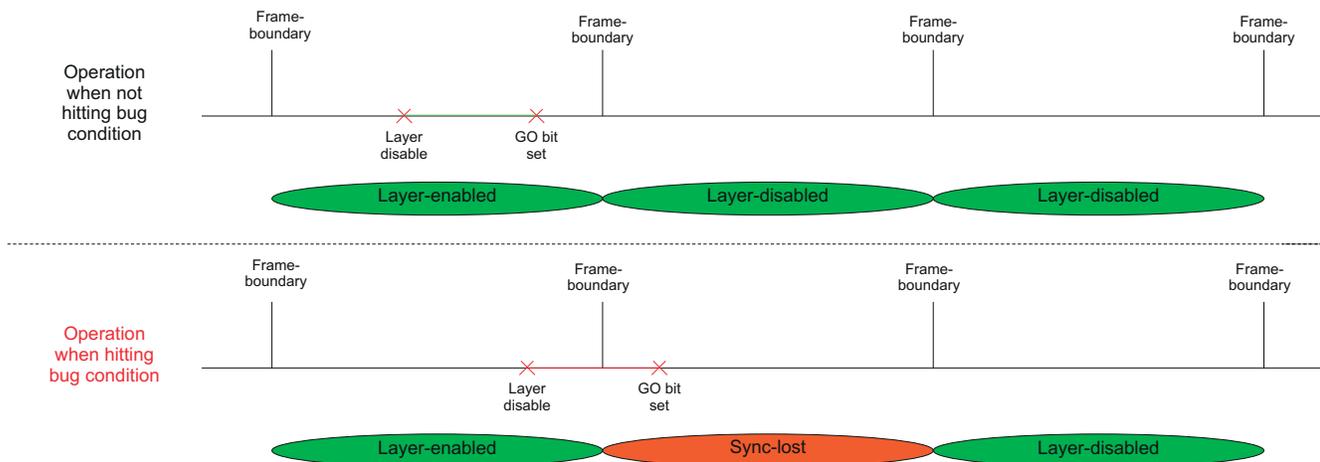
Figure 2-1. Bug Condition

i2097 **DSS: Disabling a Layer Connected to Overlay May Result in Synclost During the Next Frame**

Details: Disabling a layer (for example VID1) connected to an OVR (that is toggling DSS_VID_ATTRIBUTESx[0] ENABLE from 1 to 0) may result in synclost during the next frame. The synclost may result in a corrupted or blank frame (all pixel data sent out of DSS during the frame is 0x0). The occurrence of synclost is dependent on the timing of setting the GO bit (that is DSS_VP_CONTROL[5] GOBIT to 1) vis-à-vis the disabling of the layer. If the “disable layer” MMR write operation and “set GO bit” MMR write operation happens within the same frame boundary, no synclost occurs. If the operations happen across the frame boundary, then synclost occurs (for one frame). The design automatically recovers and returns to normal operation from the next frame after GO bit is set, see [Figure 2-1](#).

Workaround(s): A simple software workaround exists. In the workaround, prior to disabling a layer on the OVR, it is moved to the “non-visible” area of the OVR (for example: DSS_OVR_ATTRIBUTES_x[17-6] POSX = max_value_of_posx or DSS_OVR_ATTRIBUTES_x[30-19] POSY = max_value_of_posy). This avoids the synclost when the layer is disabled.

A sample software workaround pseudo-code is shown on [Figure 2-2](#). In this case, the regular “disable layer” MMR write operation and “set GO bit set” MMR write operation are replaced with macros which implement the software workaround.
