## 1 Introduction

This document describes the known exceptions to the functional and performance specifications to TI CMOS Radar Devices (AWRL1432 )

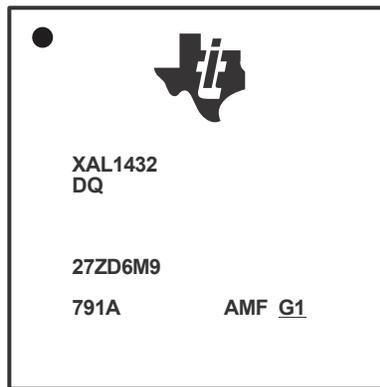
Figure 3-1. Example of Device Part Markings

Figure 3-1 shows an example of the AWRL1432 Radar Device's package symbolization.

This identifying number contains the following information:
